# Failures in Progress

Since June, 2003, Pepper Maintenance® has been observing and monitoring the imminent failure of an extremely large, high horsepower gear reducer. The customer is fully aware of the deteriorating condition of the equipment. Pepper Maintenance® will continue to monitor the situation until the customer is able to remove the equipment from service for maintenance and repair.

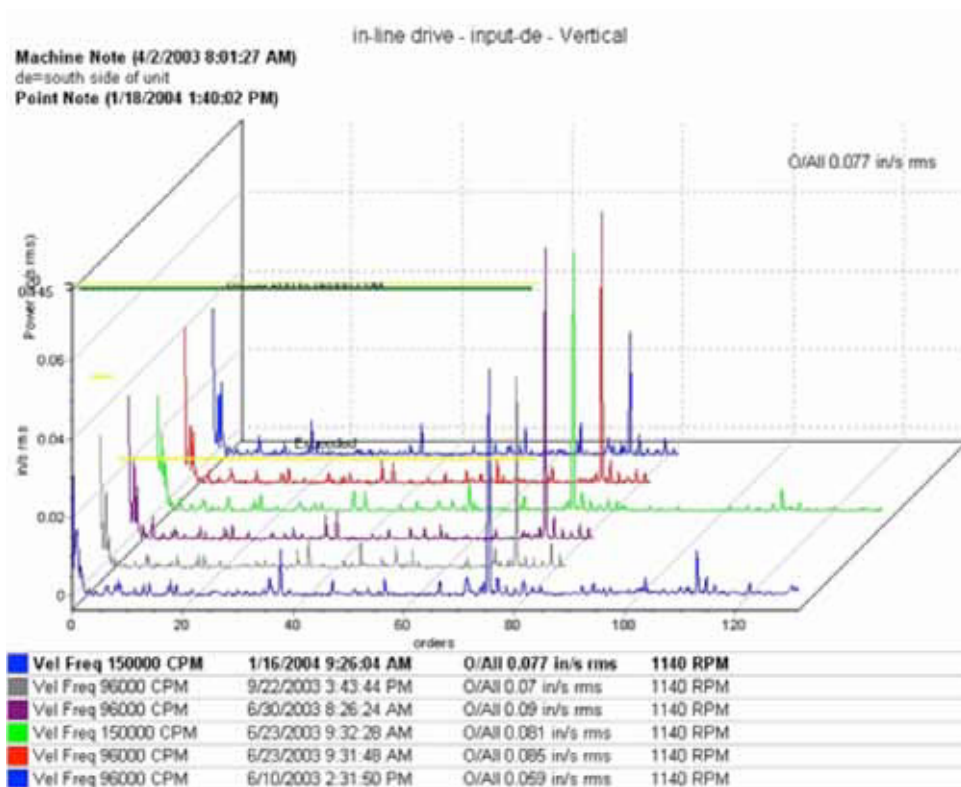
The signatures of failure are graphically obvious in the real-life illustrations exhibited here. Follow the detective-technician's trail as he listens to the heartbeat of this huge reducer over multiple, consecutive visits. These signatures are from the actual report provided to the customer, showing the progressive deterioration.
